Report of Findings

Aircraft Registration: N957MD

Aircraft Type: Czech Sport / Piper Sport

NTSB or TSB File Number: ERA14LA316

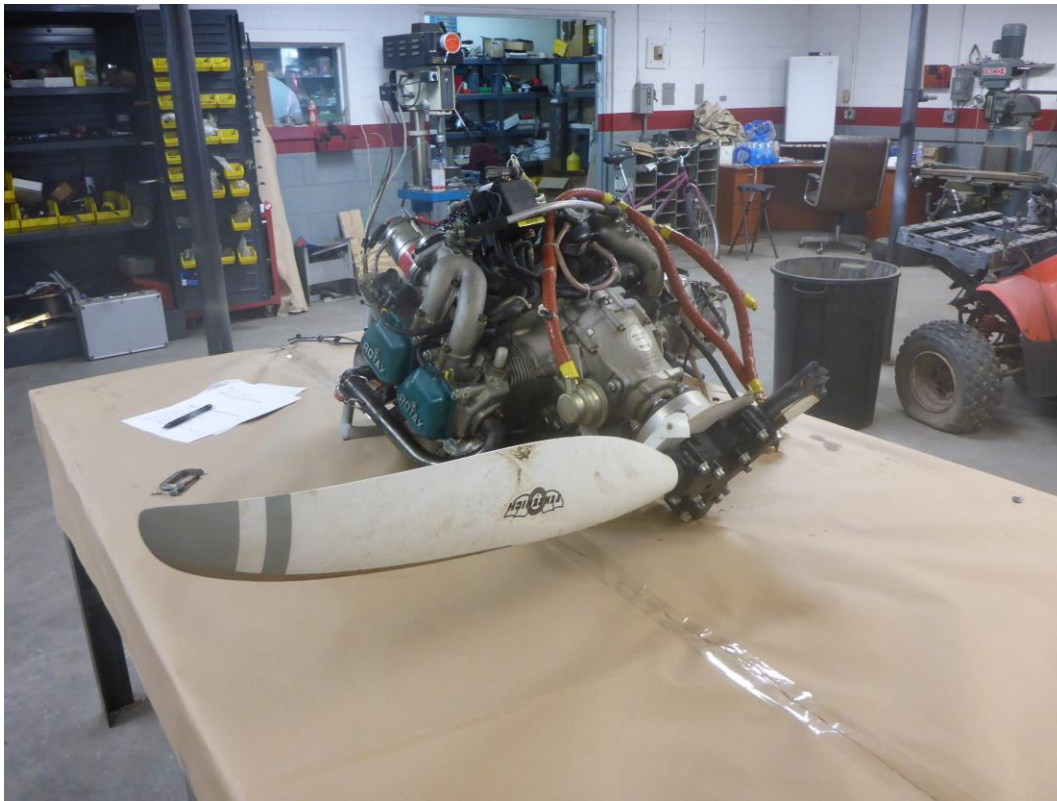
Engine and aircraft substantially damaged from impact:

- Oil tank crushed
- Oil pump broken at oil filter mounting point
- Oil system breached
- Cross over tube on intake broken
- 1/3 & 2/4 Carburetors displaced
- 3 blade propeller with two blades broken and one blade still attached
- Exhaust system damaged
- Carburetor sockets damaged
- Oil pump filter flange broken from oil pump
- Coolant radiator crushed and breached

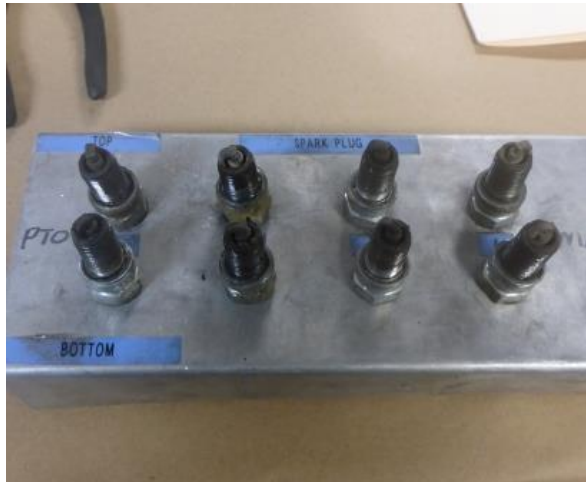
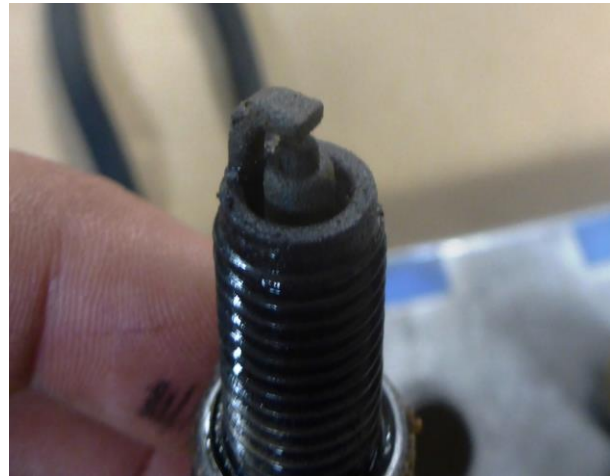
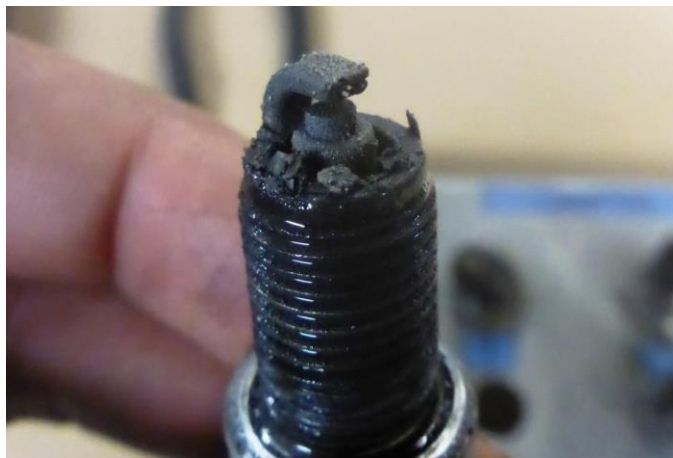
Spark Plugs & Spark plug Caps

All spark plugs were NGK DCPR8E and were found to be in very poor condition. [REDACTED]

The physical condition of the spark plugs were the only anomalies that could be found during the examination and test run of the engine. Even though the engine test ran fine with the original spark plugs, it could not be determined how the condition of the spark plugs would affect the overall performance of the engine during takeoff and cruise.

Rotax maintenance manual states the spark plugs should be inspected and cleaned every 100 hours and replaced every 200 hours. If the use of leaded fuel is more than 30% of the time, then the spark plugs are to be replaced every 100 hours.

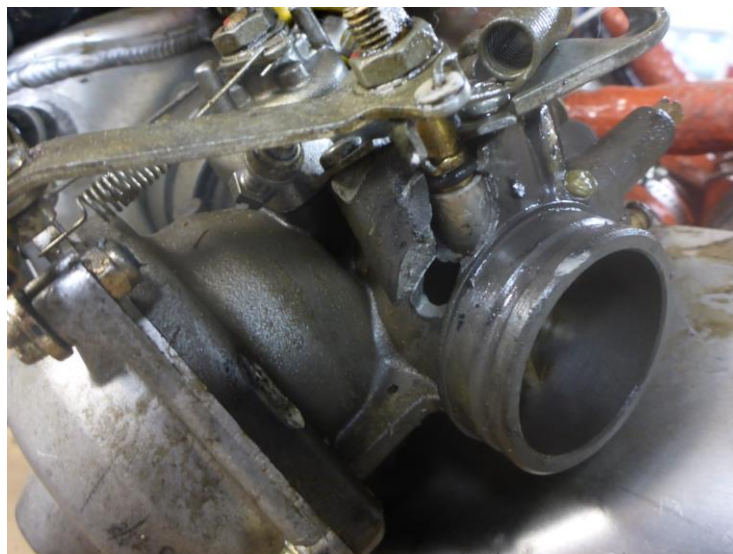
Fuel supply including fuel pump

The carburetor float bowls were removed and examined for fuel and contamination. No fuel or contamination was found. The carburetor main jets were examined for the correct size and blockage. The Carburetor main jets were the stock 155 size and no blockages were found.

The tops of the carburetor were dismantled to inspect the condition and configuration of the Jet needle. The Jet needle was in good condition with the needle clip in the stock number 2 position.

The 2/4 carburetor body was damaged from impact and could not be used for any future test run purposes.

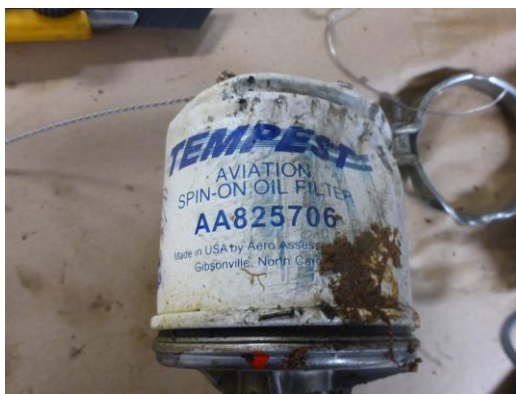
The oil filter installed on this engine was a non-approved, non-Rotax oil filter. Rotax Service Letter SL-912-014 R5 states Non-approved modifications or use of Rotax unapproved engine components or accessories for Rotax aircraft engines could result in engine damage, personal injury or death.

This service letter SL-912-014 RT section 3 subsection 3.1.2) Example of a non-genuine ROTAX oil filter specifically states non-genuine ROTAX oil filter are not airworthy and should not be installed or be further used according to ROTAX instructions.

The type of oil filter that was installed on this engine was an aftermarket Tempest Oil Filter P/N AA825706.

The proper and approved oil filter is a Rotax Oil filter P/N 825 012

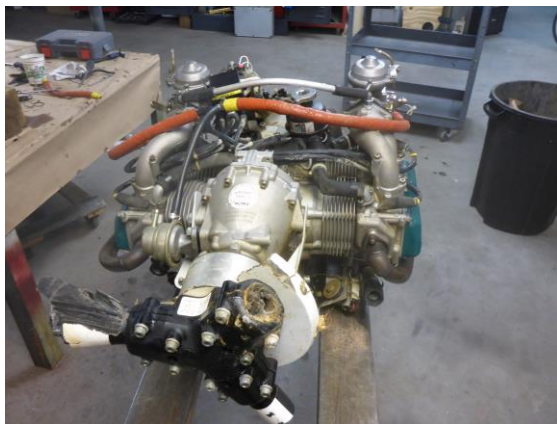
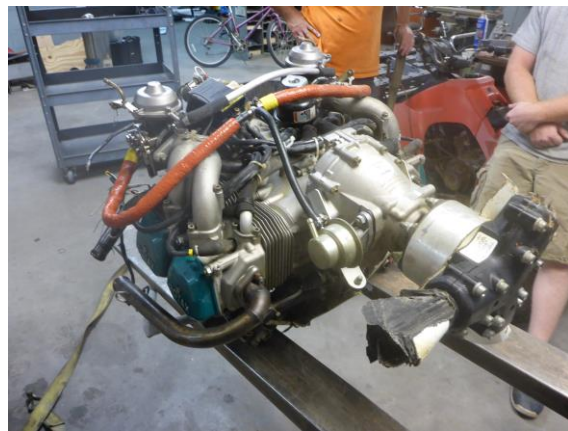
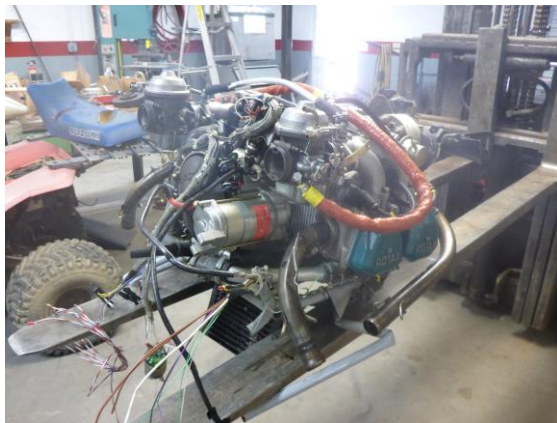
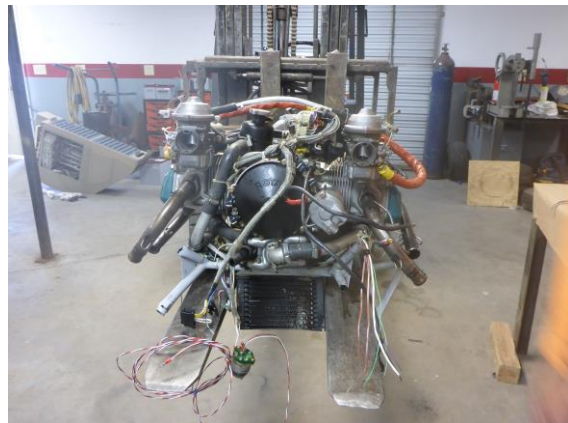
Engine Test Run

A fork lift was used as a makeshift engine test stand and the engine was secured to the forks with the use of ratcheting straps and tie down straps. A battery was connected to the starter of the engine and the rotary switch was turned to start the engine.

The throttles were manipulated by hand and the engine ran for several minutes. The engine ran at several different RPM settings until it was manually shut off by turning the rotary switch to the off position.

There were no anomalies found during the engine test run.
